METRO
CAULFIELD
SIGNALLING DIAGRAM No. 79/18
 (Replaces No.45/18)

Showing Signal and Interlocking Arrangements to come into use on a date to be fixed by Circular which will be issued by the Rail Safety Manager

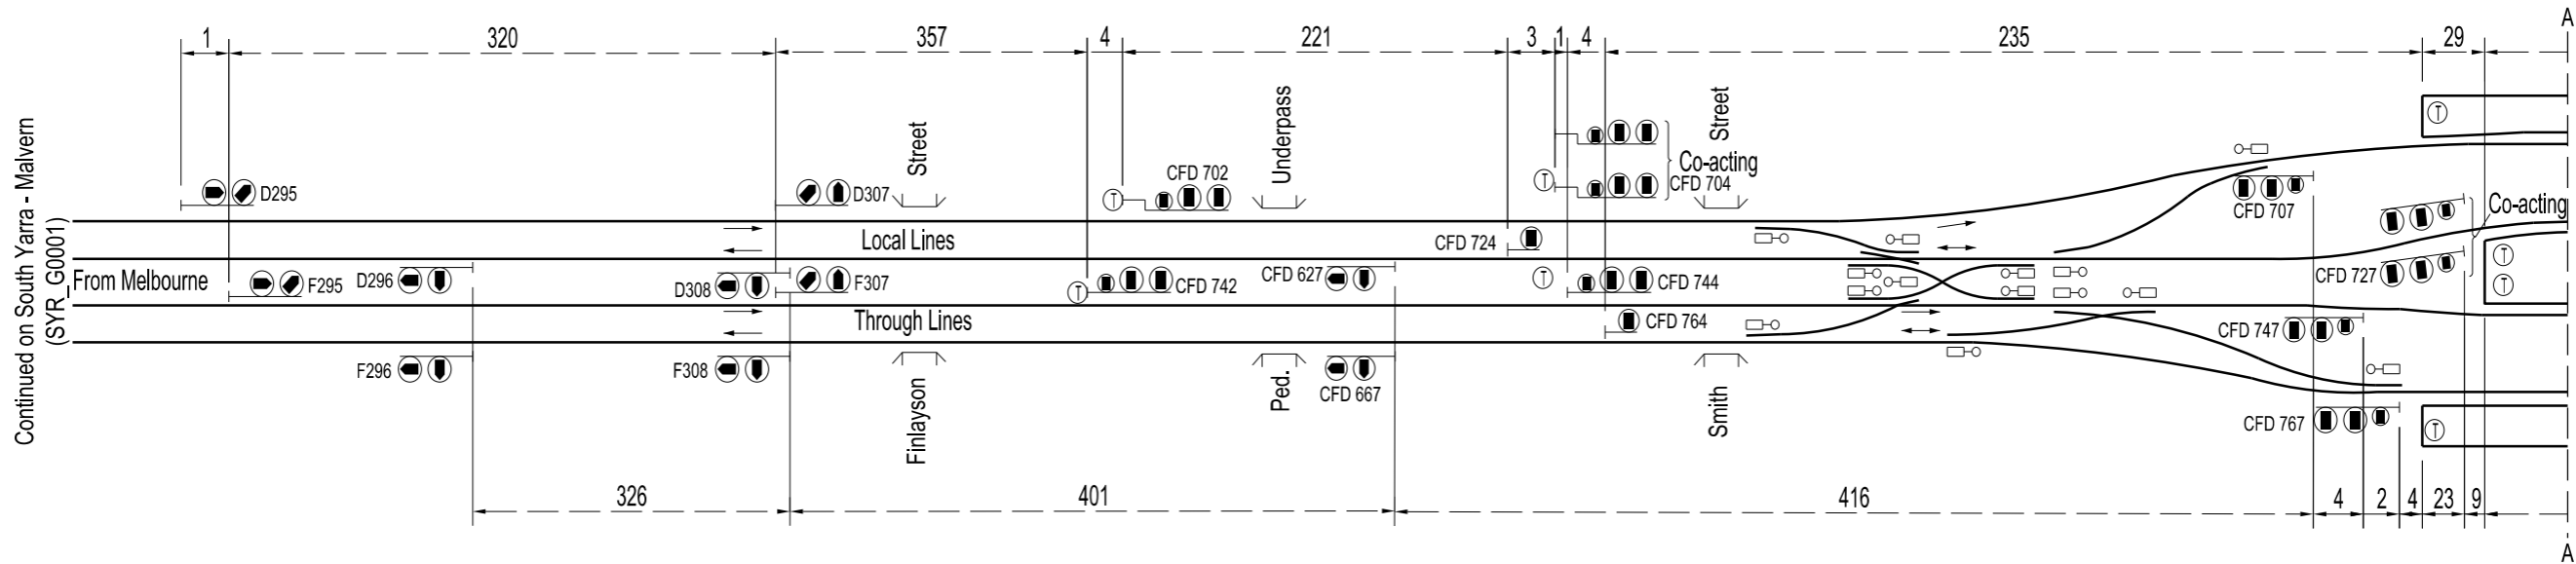
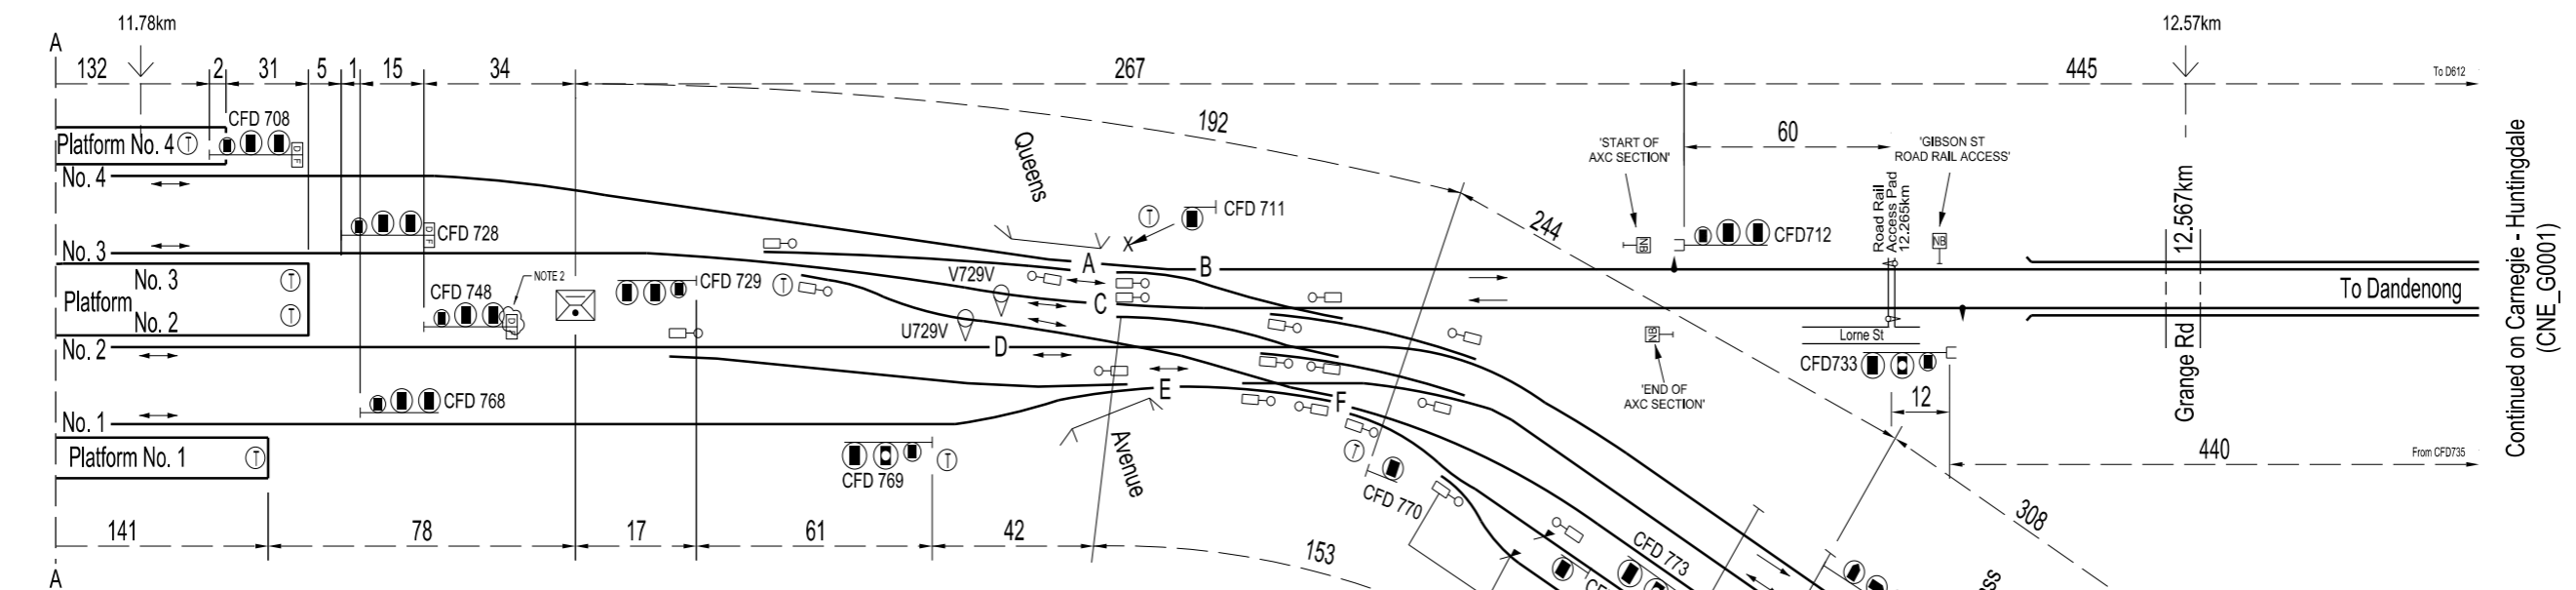
Signal fixed at stop

Illuminated letter 'A' not commissioned
